Manhole Inspection Summary

Manhole # S31G__028MH

Location Address: **14 s eutaw st**

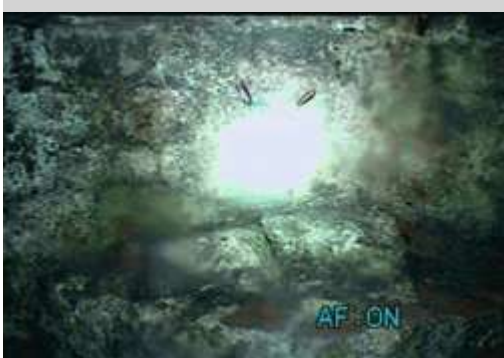
Defect 3

Condition: ☐ Sound ☐ Cracked ☐ Root Intrusion ☐ Deteriorated ☐ Leaks ☒ **Debris**

bench debris

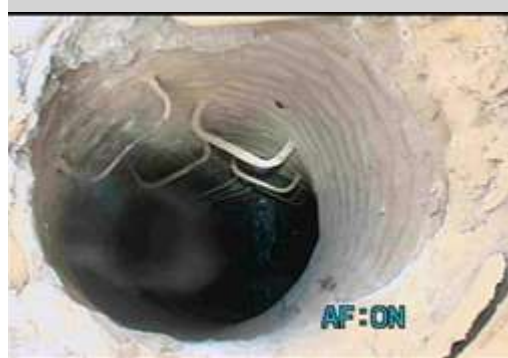
Defect 2

Condition: ☐ Sound ☐ Cracked ☐ Root Intrusion ☐ Loose Brick ☒ **Deteriorated**

Count: **12** Missing: **0** ☒ **Corroded**

deteriorating corbel, corroded steps

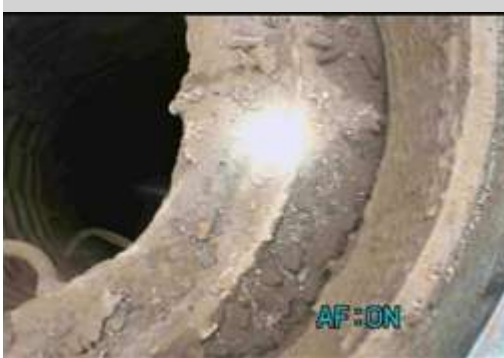
Defect 1

Offset: **8** (in.)

offset
